SCOB * Q46 86-108099/17 * EP-178-842-A
Repair system for power cable utility poles - includes excavating to allow fitting of multi-part sleeve around pole and filling of gap with non-shrinking hardenable cement

⑰ **Repairing utility poles.**

EP 0 178 842 B1

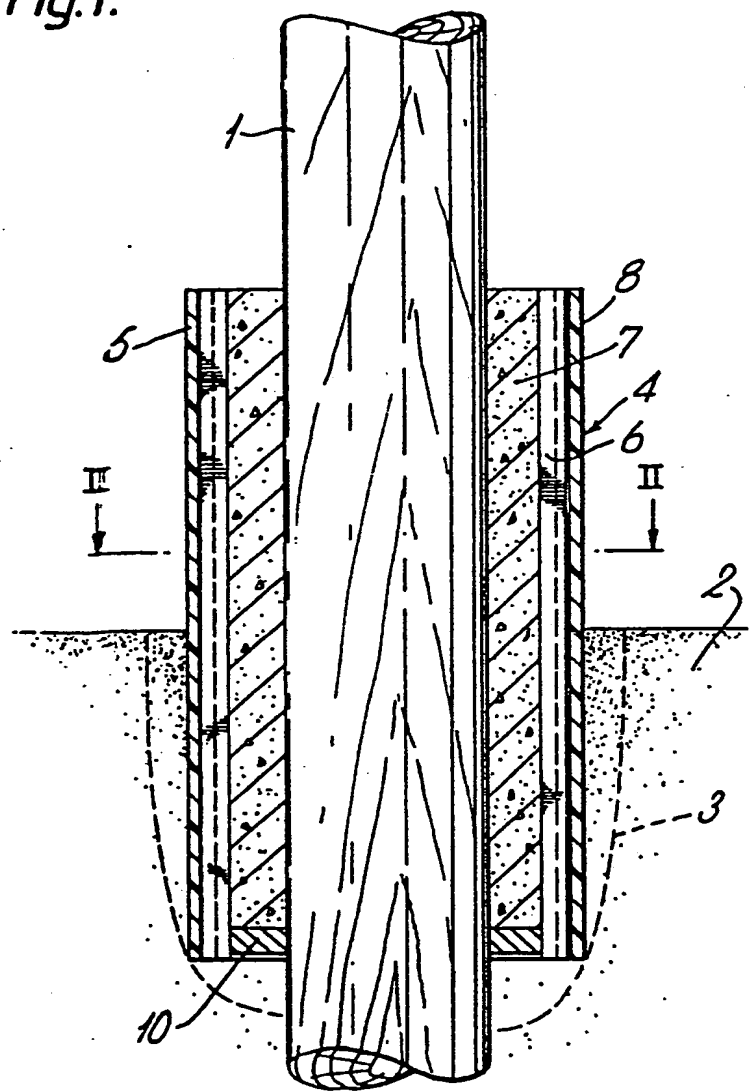
Fig.1.

Figure 1 is a diagrammatic section through a utility pole about where it leaves the ground;

With reference to the drawings, a utility pole 1 may be a cylindrical wooden pole and has previously been set in the ground 2 by the digging or boring of a hole. If damage or attack has occurred to the pole at or below ground level (which is the most common position for such damage, corrosion or rotting) it is repaired by the excavation around the pole of a small void (dotted lines 3) and the placing around it of a multipart sleeved construction 4. As seen in Figure 2 in the present embodiment this construction has two equal and identical halves 5 which can be clipped together by manual distortion of the sleeves, so that flange 6 is trapped by claw 8, each extending along respective edges of the half-sleeves. An alternative method of clipping the halves together is shown in Figure 3, with a U-strip 9 passed over the out-turned flanges 6'. At the bottom and indeed elsewhere on the sleeve may be spacers for maintaining a regular and desired spacing between the inner circumference of the sleeve parts and the pole. The appropriate spacing will depend on the dimensions of the pole and its expected loading. As seen in Figure 1, a ring 10 closed around the pole may act simultaneously as spacer and as a seal for the bottom of the sleeve.

Once placed the gap between the sleeve and the pole is filled with a hardenable core material 7 the general nature of which has already been discussed and which is to bond both to the pole and to the sleeve. The material is then left to harden in situ. The gap may be filled through an aperture in the flange 6 or in the wall of the sleeve parts 5, or from the top of the gap.

A preferred length for the sleeve also depends on loading considerations but a standard length of 2 metres, of which 1 metre is intended to be below and 1 metre above ground will serve for most purposes.

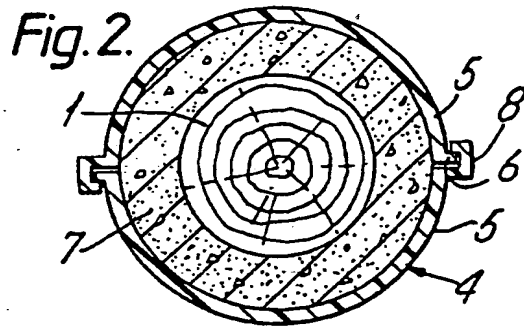
Figure 2 is a section on the line plane 2.2 of Figure 1,

Figure 3 shows an alternative on the same section; and

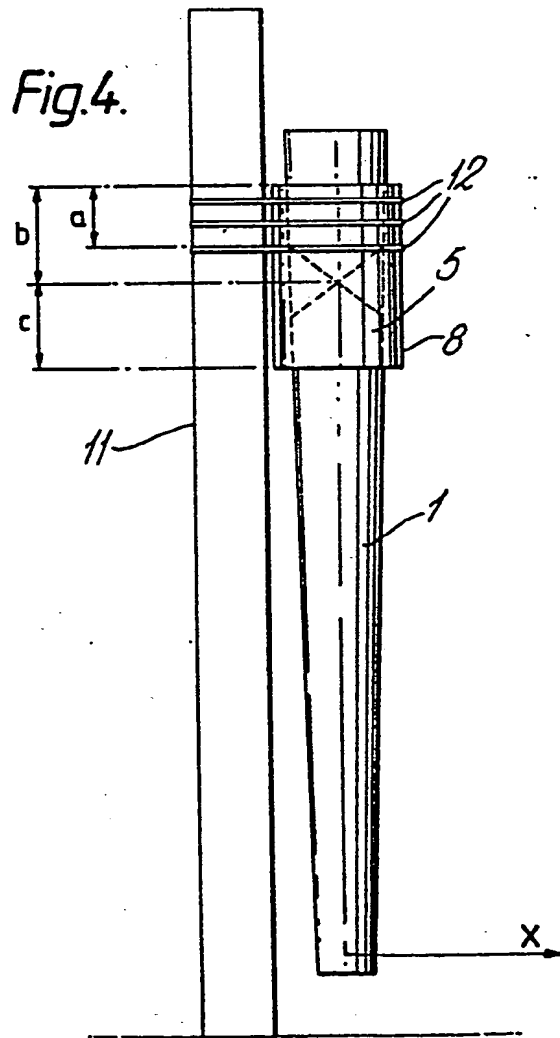
Figure 4 shows a test rig.

Fourteen days after the repair was made the poles 1 were tested in a special rig in which they were held vertically on a support frame 11 by support straps 12 near the repaired end as shown in Figure 4. Dimension a is 0.5 m, b and c, 1 m. Loads were applied horizontally along arrow x at the undamaged end and the results obtained are shown in Table I. As can be seen the percentage of nominal strength attained was very high. In both cases the figure of 60%, which has been regarded as acceptable, was well exceeded, and similar successful results would be obtained using a minimal-shrink grouting cement or a minimal-shrink non-reinforced thermoset resin.

Repairs were made on two full size poles A and B in which damage had been simulated by cutting V-notches at the position of maximum bending moment to simulate ground level damage. The V-notches were filled with foam of no significant mechanical strength to prevent ingress of cement into the V's. Glass reinforced plastic (GRP) sleeves were then fitted round each pole, each sleeve being 2 metres long and consisting of half-round sections 5 and fixed with GRP clips 8 which slid on flanges 6' as shown in Figure 3. The spacing from the pole was about 22 mm all round. The core material 7 was a non-shrink magnesium phosphate cement as described by Abdelrazig et al, *loc cit*.
